# **The Road Inventory of Ridgefield National Wildlife Refuge Ridgefield, WA**

Prepared By:  
Federal Highway Administration  
Central Federal Lands Highway Division  
February 2013

## Ridgefield - 13551

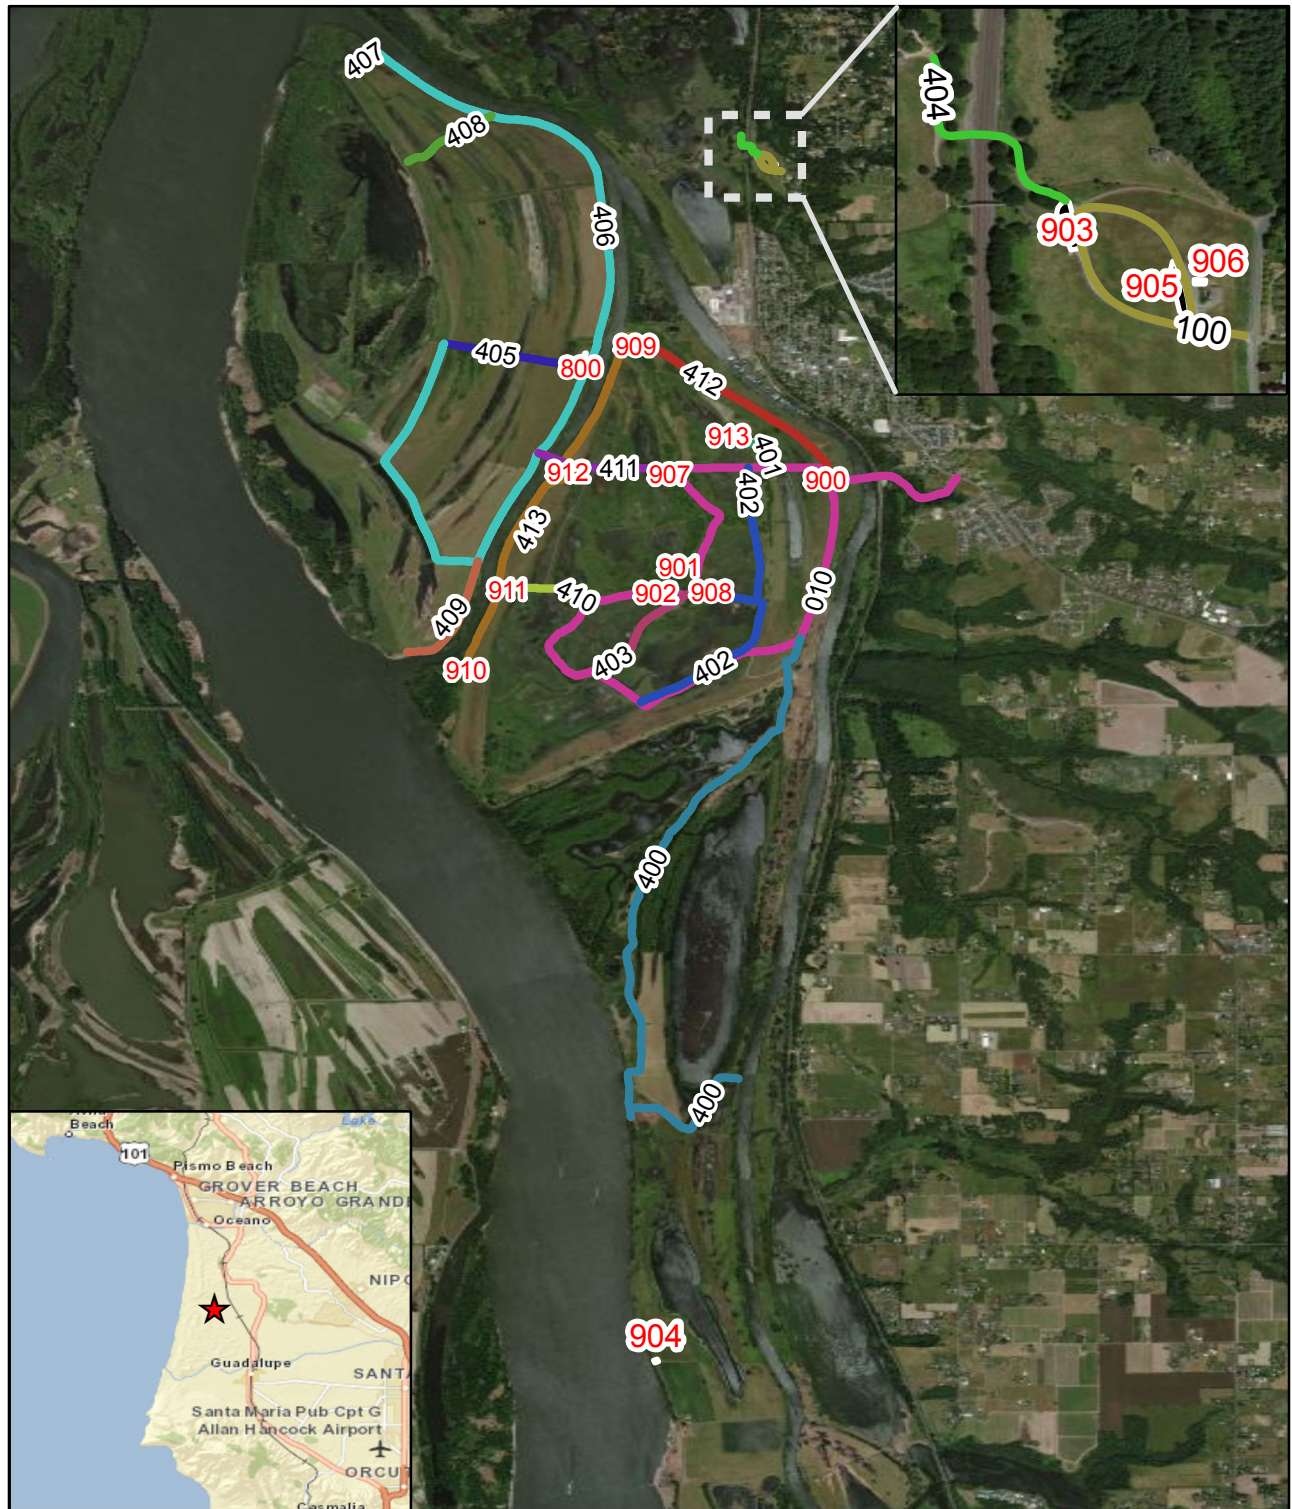
## Route Location Map

# Ridgefield National Wildlife Refuge

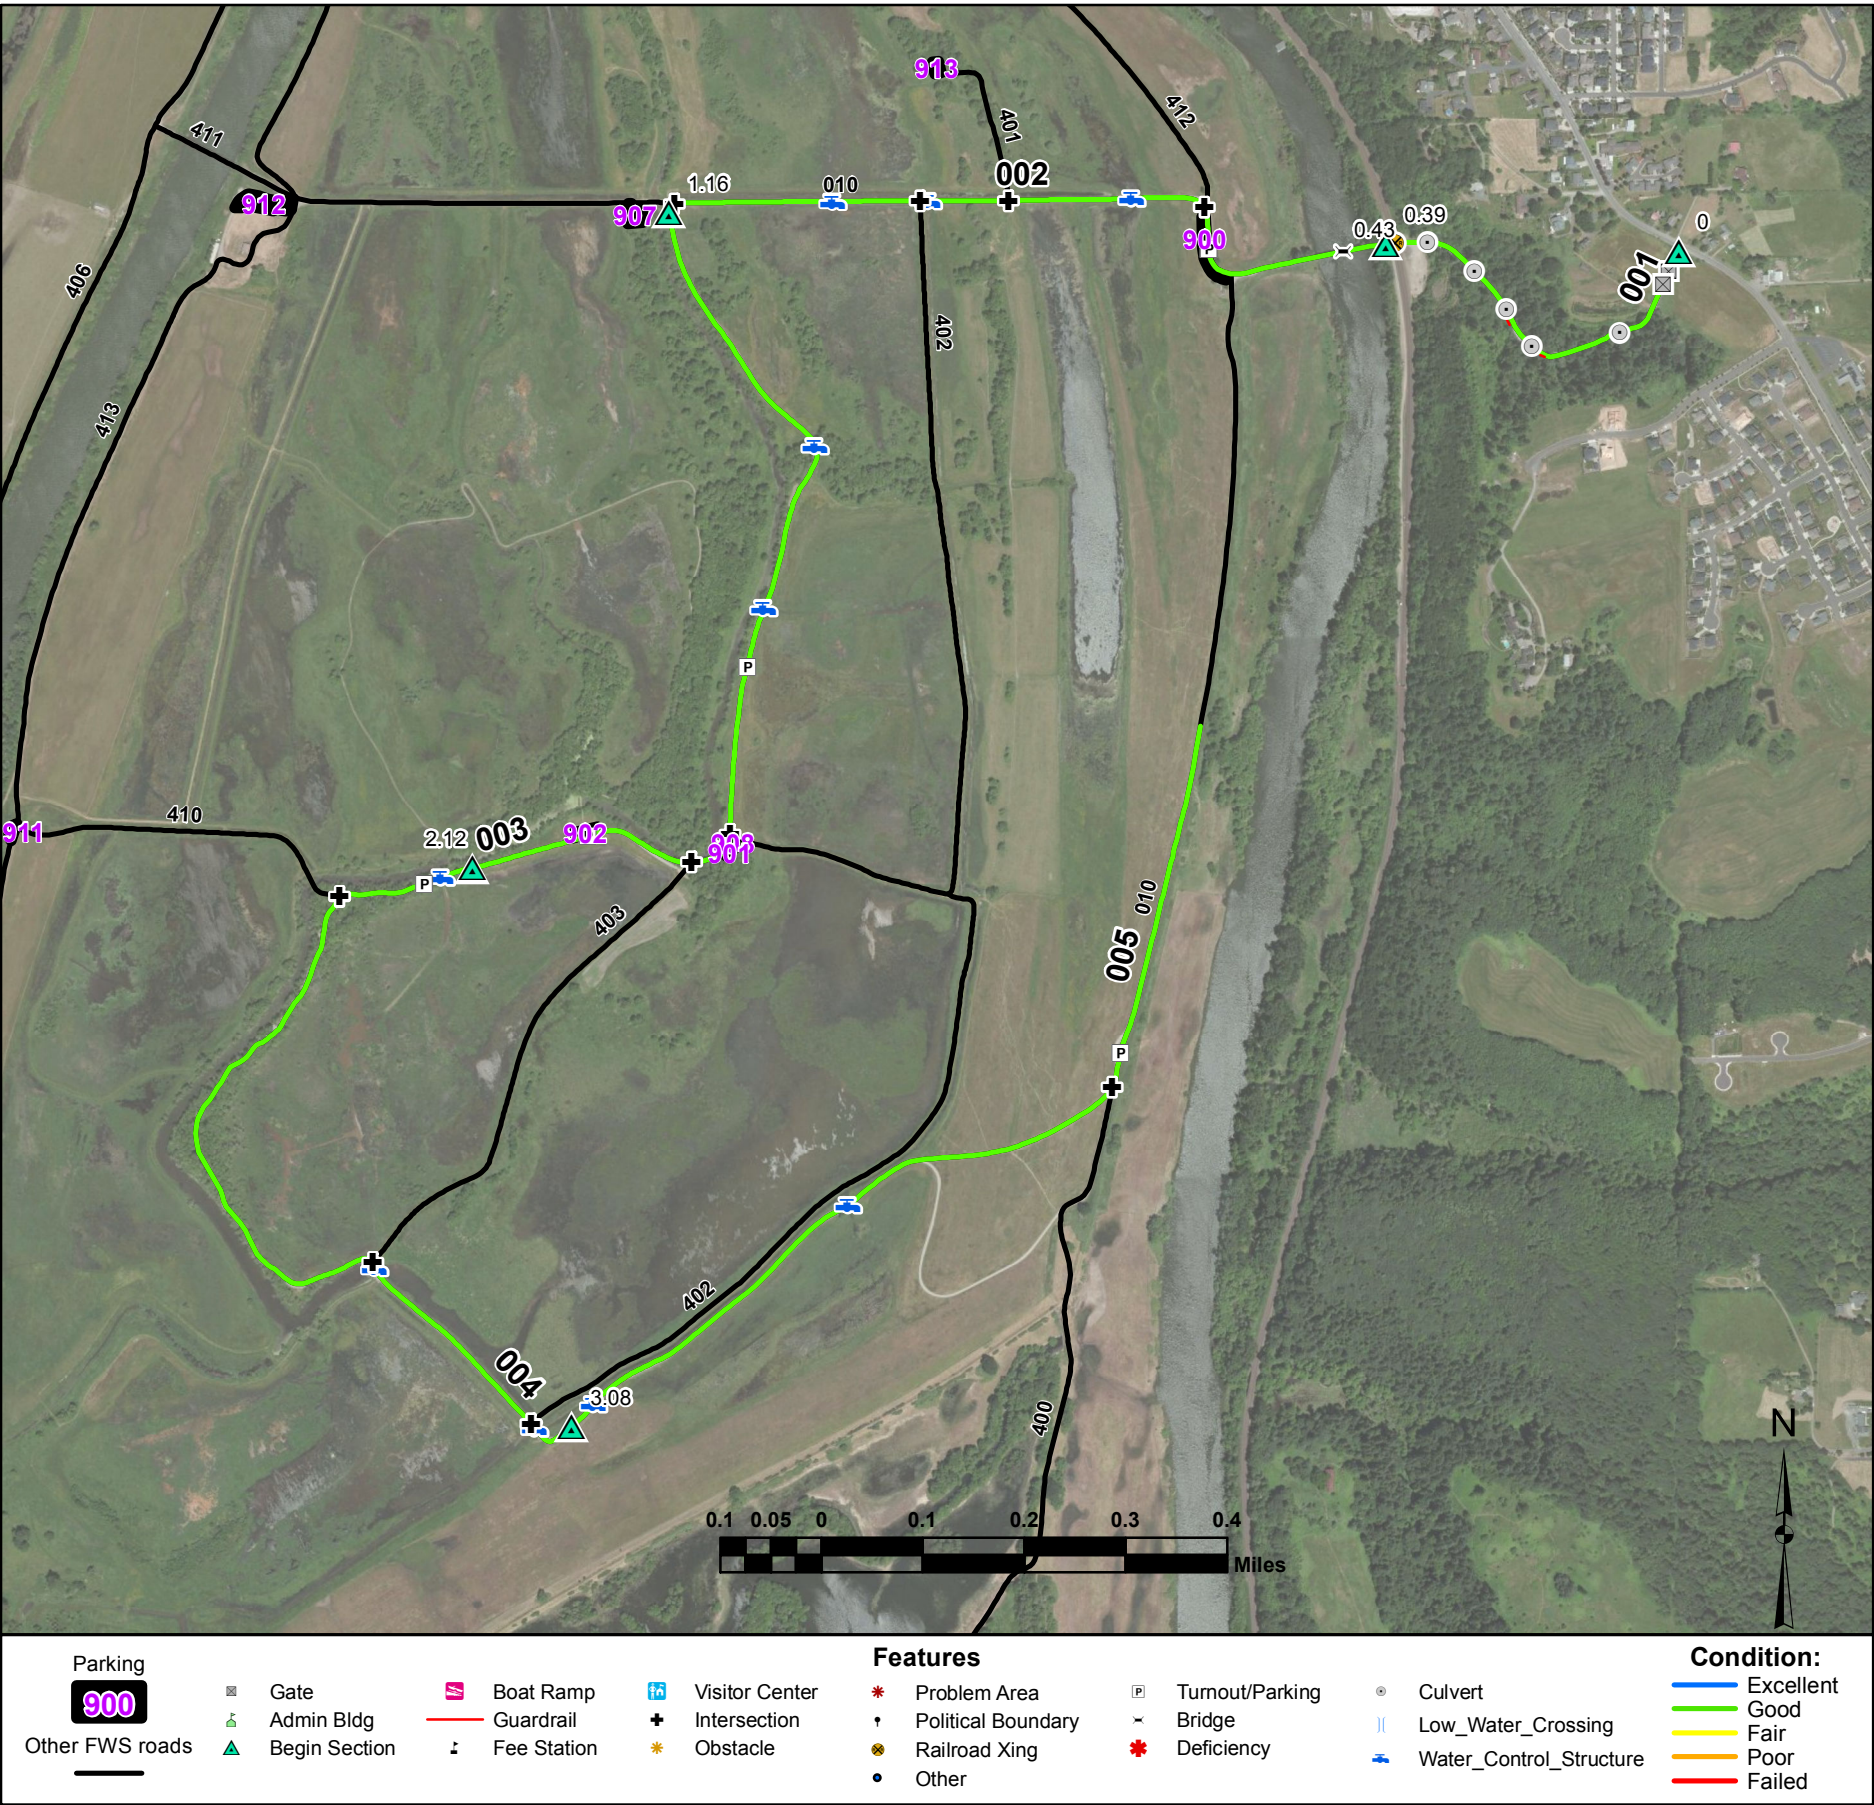
From State Road 501 to end of Auto Tour Loop

Asset Number	10003593	10003593	10003593	10003593	10003593
Section Number	001	002	003	004	005
Section Length (miles)	0.39	0.77	0.96	0.96	1.01
Inspection Date	11-29-2012	11-29-2012	11-29-2012	11-29-2012	11-29-2012
Surface Type	Gravel	Gravel	Gravel	Gravel	Gravel
Number of Lanes	2	2	1	1	1
Roadway Width (feet)	16	18	14	14	14
Condition	Good	Good	Good	Good	Good
Remaining Service Life (years)	5	5	7	5	5
Estimated Cost to Repair	\$700	\$1,400	\$1,800	\$1,800	\$1,900
Current Replacement Value	\$310,900	\$613,800	\$765,300	\$765,300	\$805,200

Features	Mile Post	Features	Mile Post	Features	Mile Post	Features	Mile Post
Begin Section	001-0.0	Water Control Structure	002-0.69	Water Control Structure	004-2.16		
Gate	001-0.02	Intersection	002-0.81	Turnout/Parking	004-2.18		
Gate	001-0.03	Water Control Structure	002-0.89	Intersection	004-2.27		
Culvert	001-0.1	Intersection	002-0.9	Intersection	004-2.8		
Begin Guardrail	001-0.18	Water Control Structure	002-0.99	Water Control Structure	004-2.81		
Culvert	001-0.2	Intersection	002-1.15	Intersection	004-3.03		
Begin Guardrail	001-0.22	Begin Section	003-1.16	Water Control Structure	004-3.03		
Culvert	001-0.24	Water Control Structure	003-1.43	Begin Section	005-3.08		
Culvert	001-0.29	Water Control Structure	003-1.59	Water Control Structure	005-3.11		
Culvert	001-0.34	Turnout/Parking	003-1.64	Water Control Structure	005-3.45		
Railroad Xing	001-0.38	Intersection	003-1.79	Intersection	005-3.78		
Begin Section	002-0.39	Turnout/Parking	003-1.8	Turnout/Parking	005-3.81

Routes modified from previous inventory:			
Rte #	Rte Name	Type of Modification	Description of Modification
10	Auto Tour Route	Geometry Change	
903	Carthy Unit Parking	Geometry Change	
901	River S Observation Concrete Parking	Geometry Change

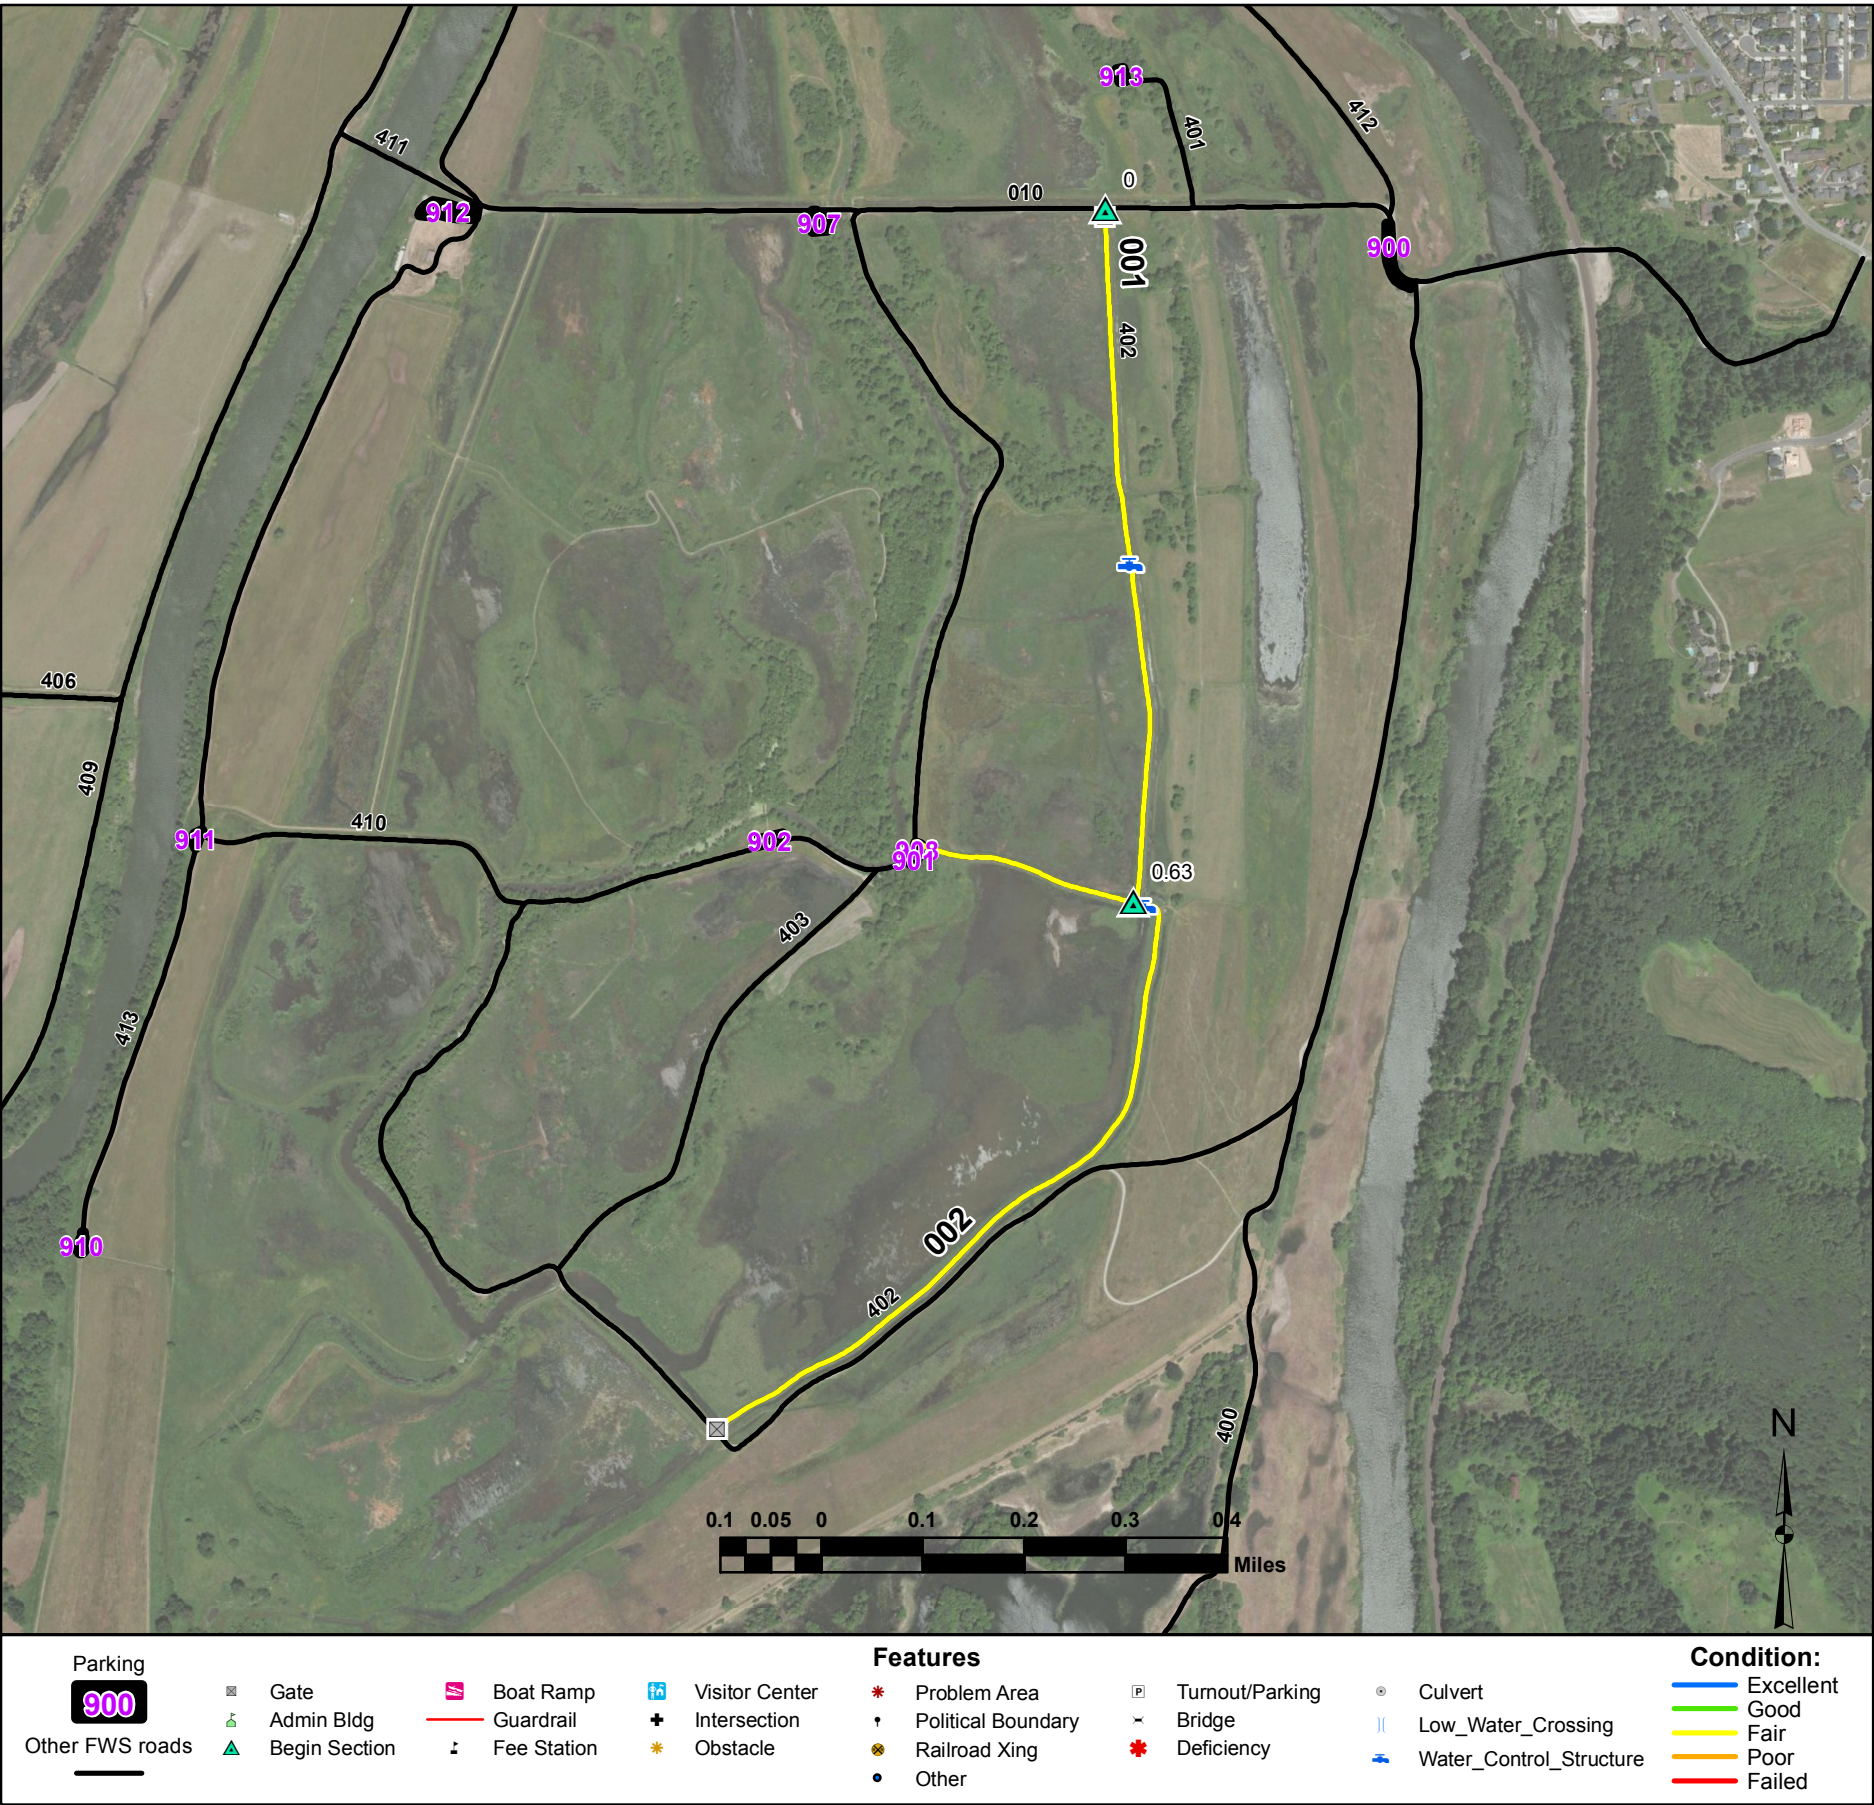
## Hunter Parking A Access Road

From Auto Tour Route (Route 010) to Hunter Parking A Parking (Route 913)

Asset Number	-				
Section Number	001				
Section Length (miles)	0.17				
Inspection Date	12-03-2012				
Surface Type	Native				
Number of Lanes	1				
Roadway Width (feet)	10				
Condition	Fair				
Remaining Service Life (years)	3				
Estimated Cost to Repair	\$400				
Current Replacement Value	\$70,100

Features	Mile Post	Features	Mile Post	Features	Mile Post	Features	Mile Post
Begin Section	001-0.0						
Culvert	001-0.0						
Gate	001-0.01						
Water Control Structure	001-0.09						
Turnout/Parking	001-0.16

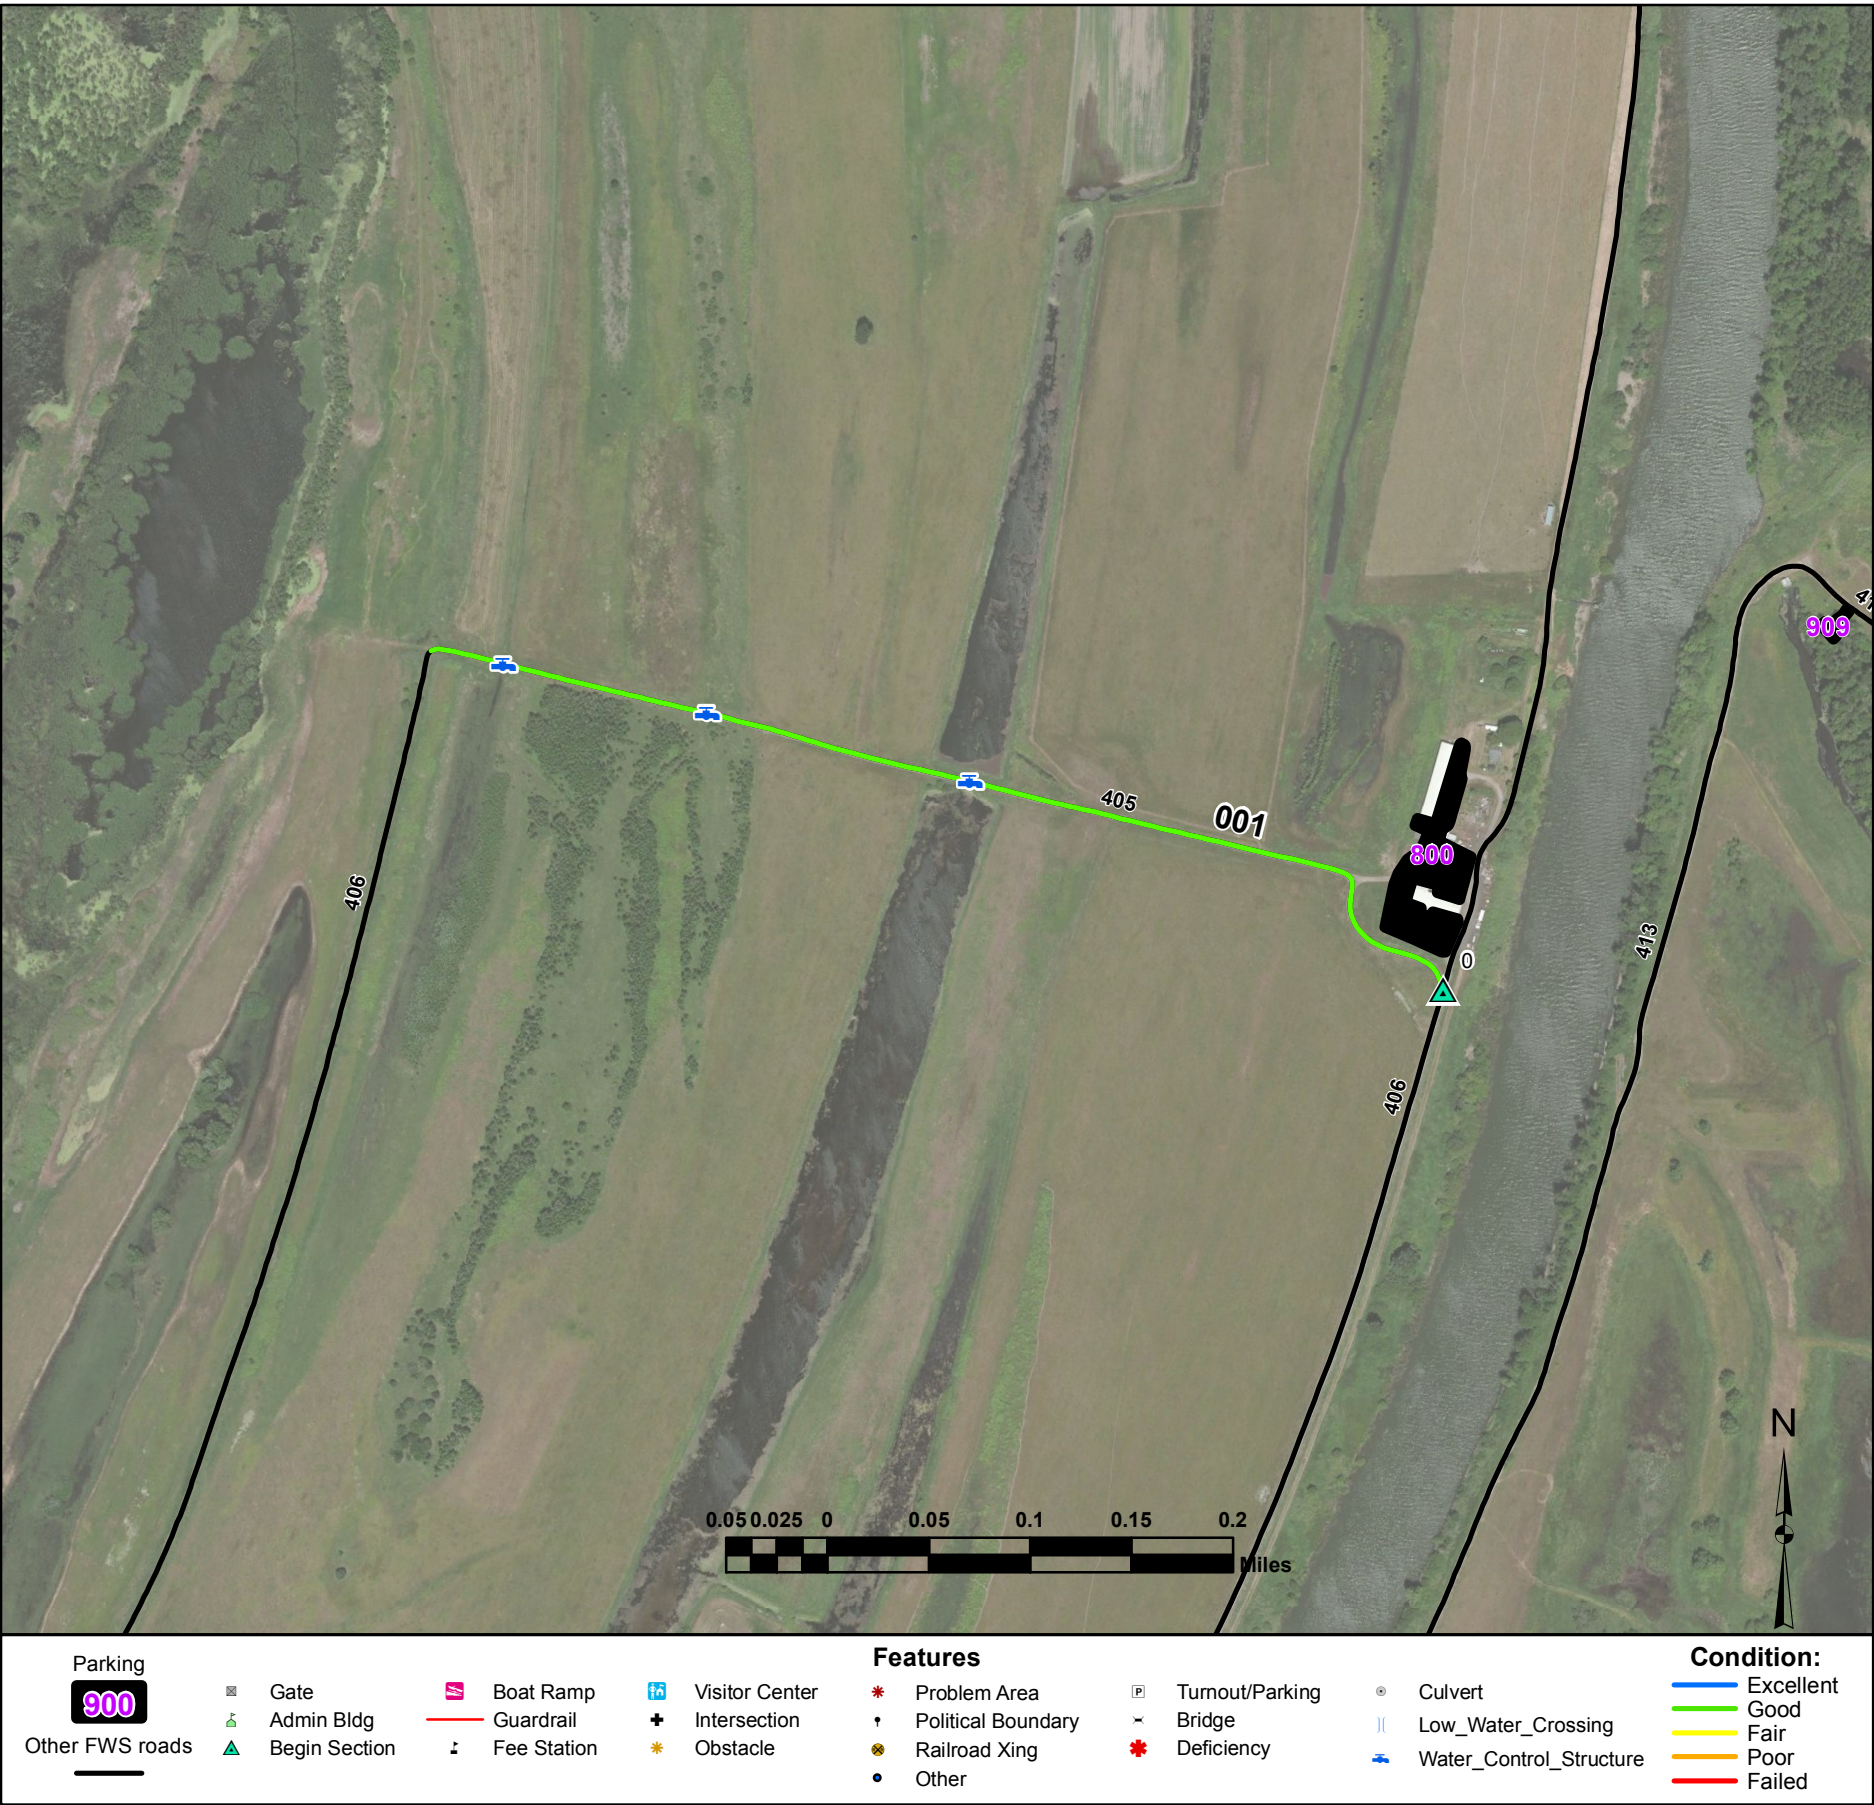
Carty Unit Road

From Carthy Unit Parking (Route 903) to wetlands

Asset Number	10003618				
Section Number	001				
Section Length (miles)	0.14				
Inspection Date	12-03-2012				
Surface Type	Gravel				
Number of Lanes	1				
Roadway Width (feet)	12				
Condition	Good				
Remaining Service Life (years)	7				
Estimated Cost to Repair	\$300				
Current Replacement Value	\$111,600

Features	Mile Post	Features	Mile Post	Features	Mile Post	Features	Mile Post
Begin Section	001-0.0						
Gate	001-0.0						
Railroad Xing	001-0.07						
Gate	001-0.08						
Problem Area	001-0.14

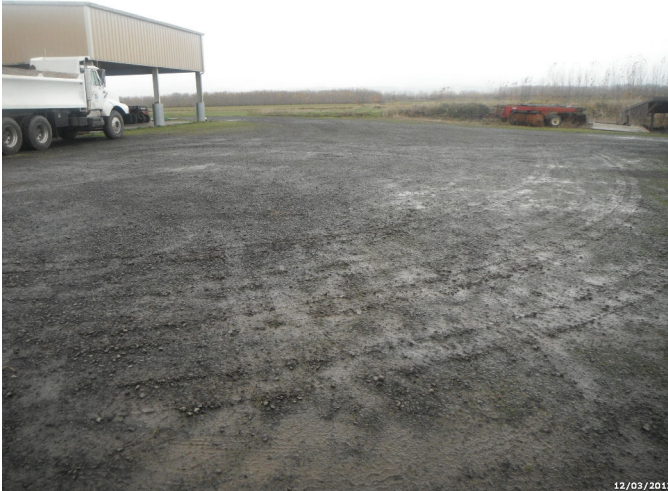
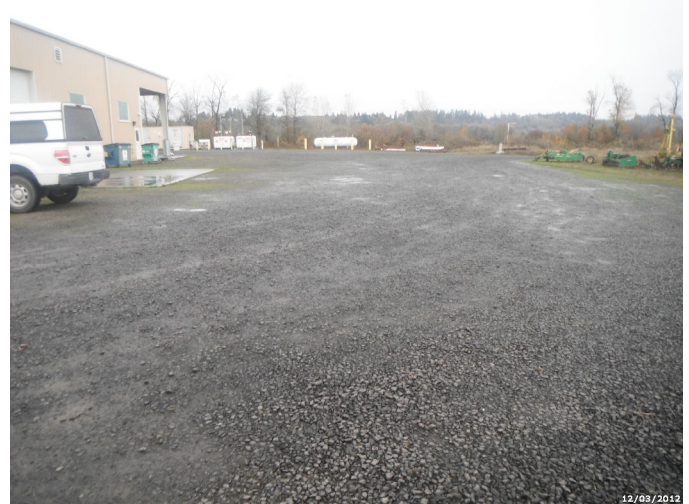
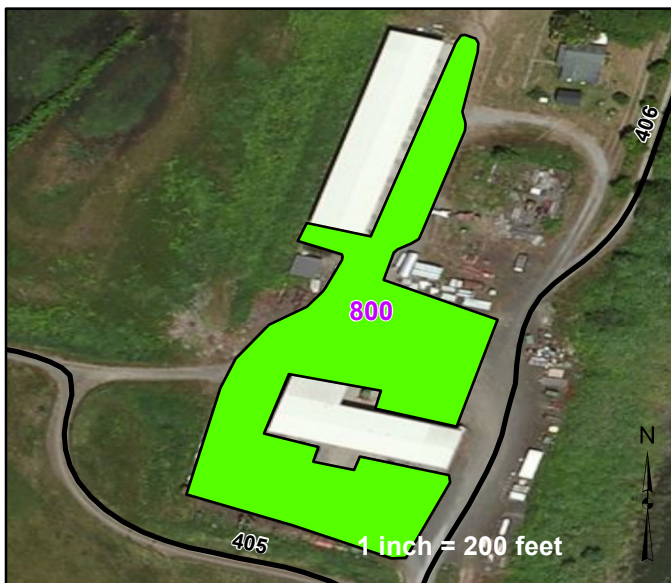
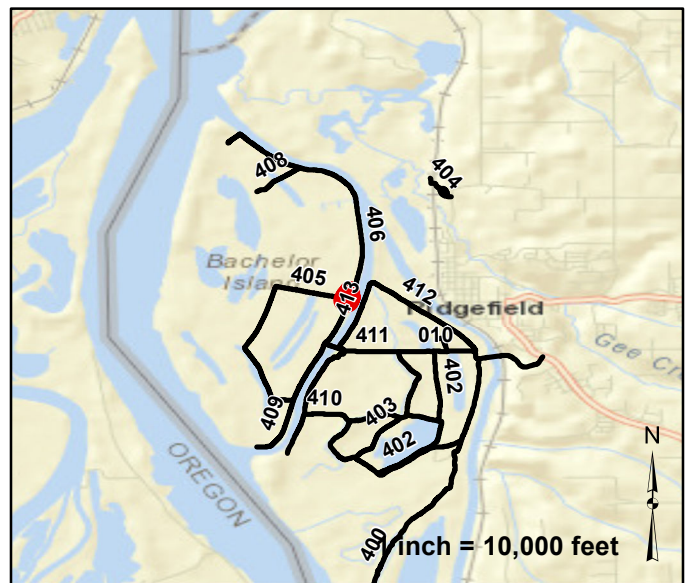
## Route Number: 800

### Shop Parking

From BI Inner Dike Road (Route 406)

Asset Number	Area (Sq Ft)	Spaces	Condition	Surface Type	Cost to Improve	Inspection Date	Current Replacement Value
-	43234	20	Good	Gravel	\$7,500	12-03-2012	\$247,400

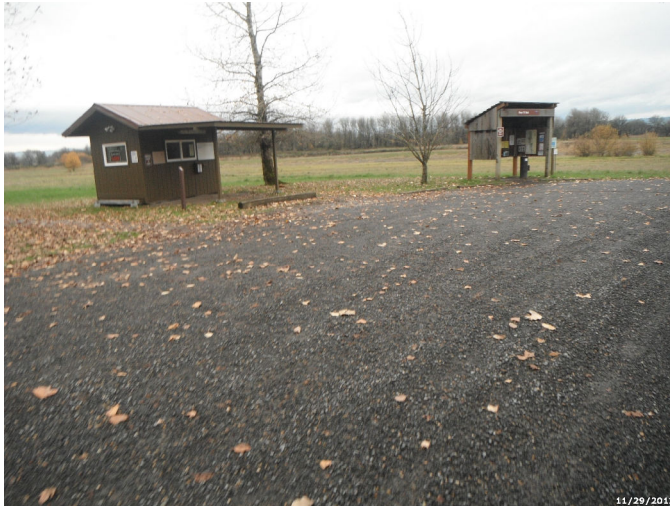
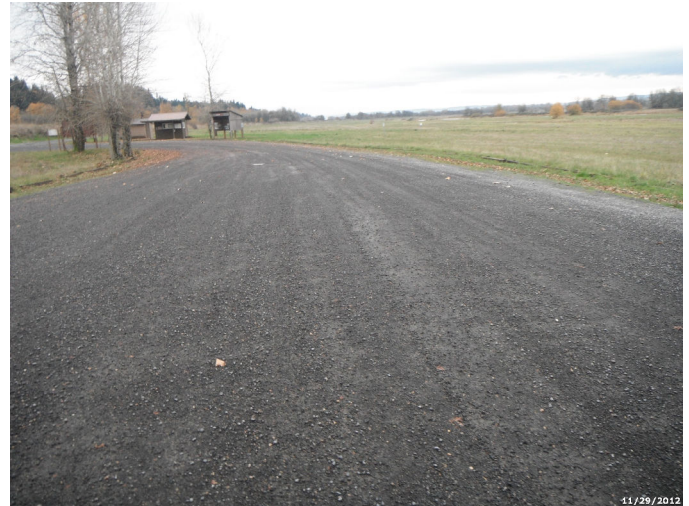
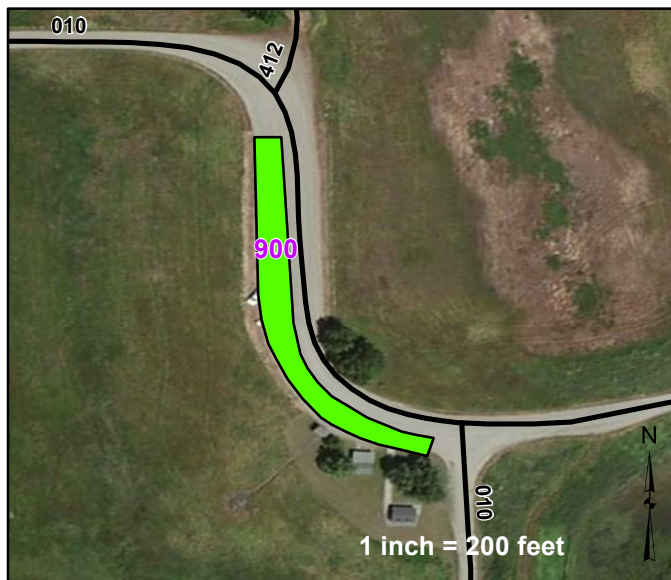
**Route Number: 900**  
**River S Unit Main Parking**  
 From Auto Tour Route (Route 010)

Asset Number	Area (Sq Ft)	Spaces	Condition	Surface Type	Cost to Improve	Inspection Date	Current Replacement Value
10036269	7853	50	Good	Gravel	\$1,400	11-29-2012	\$44,900

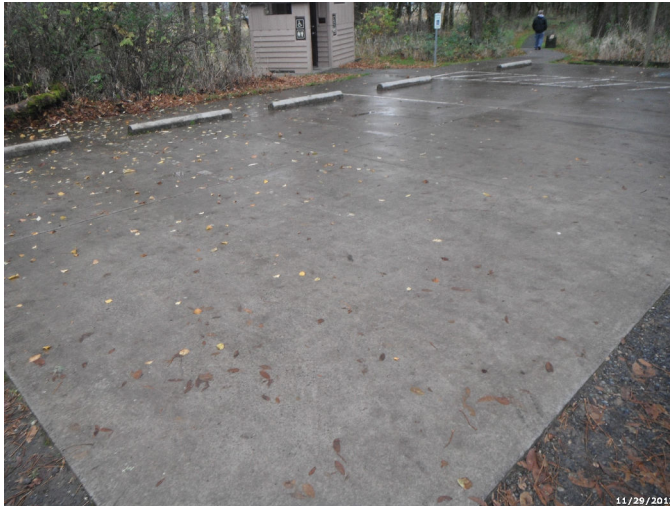
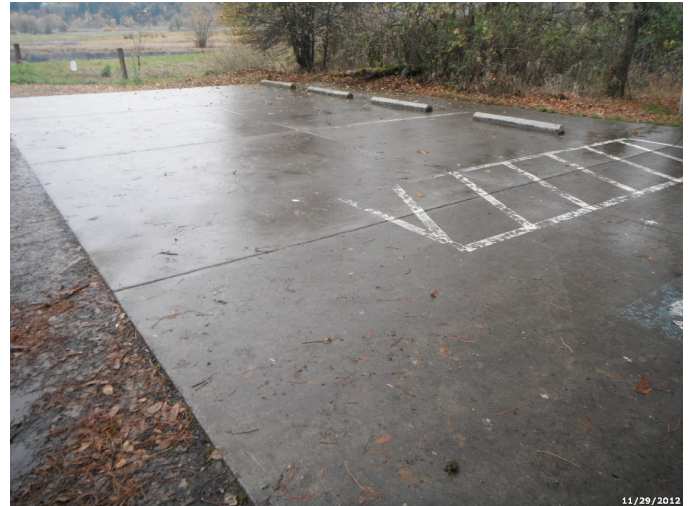
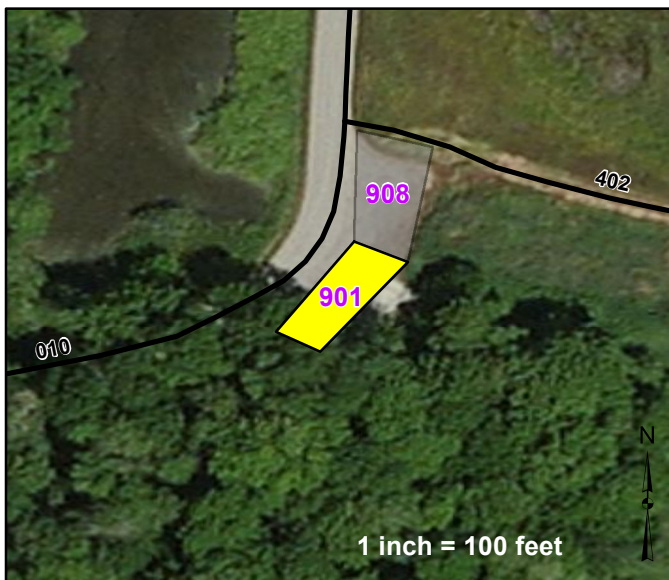
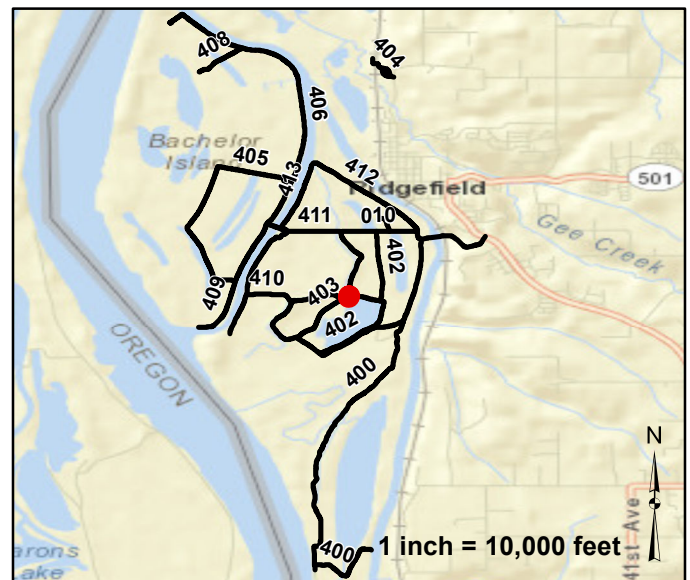
**Route Number: 901**  
**River S Observation Concrete Parking**  
**From Auto Tour Route (Route 010)**

Asset Number	Area (Sq Ft)	Spaces	Condition	Surface Type	Cost to Improve	Inspection Date	Current Replacement Value
-	1154	3	Fair	Concrete	\$2,400	11-29-2012	\$14,700

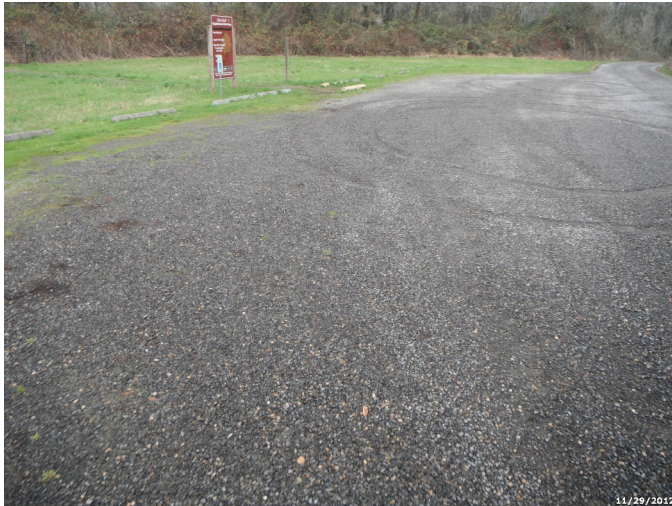
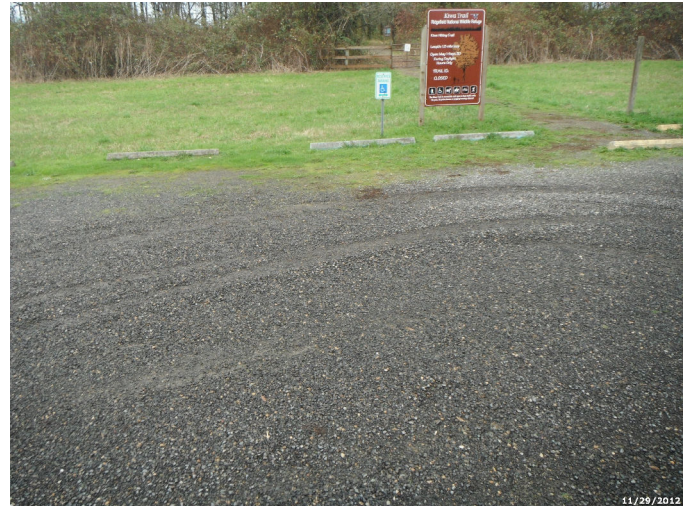
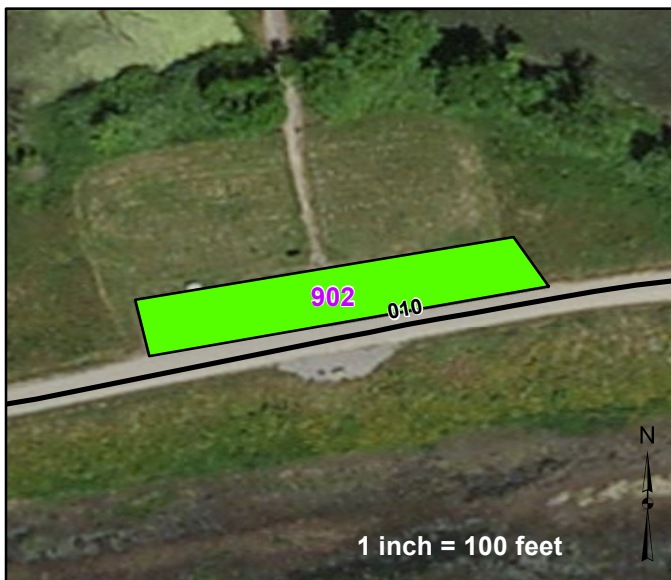
**Route Number: 902**  
**Kiwa Trailhead Parking**  
**From Auto Tour Route (Route 010)**

Asset Number	Area (Sq Ft)	Spaces	Condition	Surface Type	Cost to Improve	Inspection Date	Current Replacement Value
10036271	4178	10	Good	Gravel	\$700	11-29-2012	\$23,900

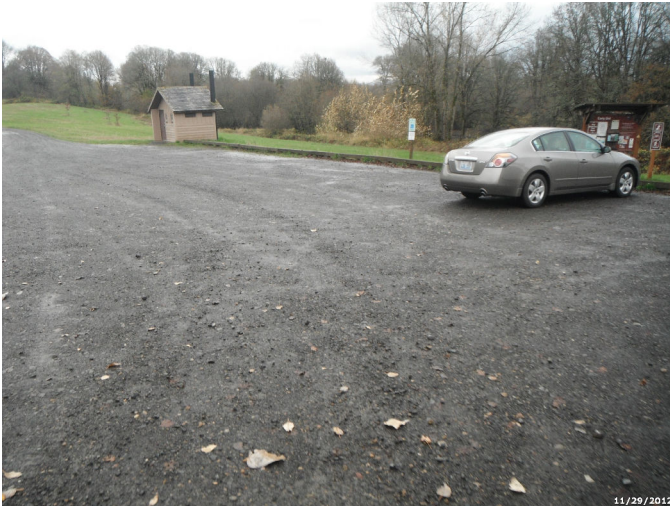
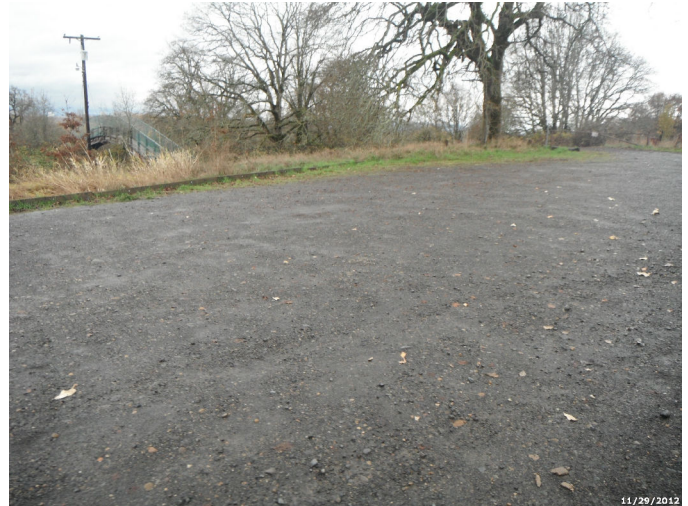
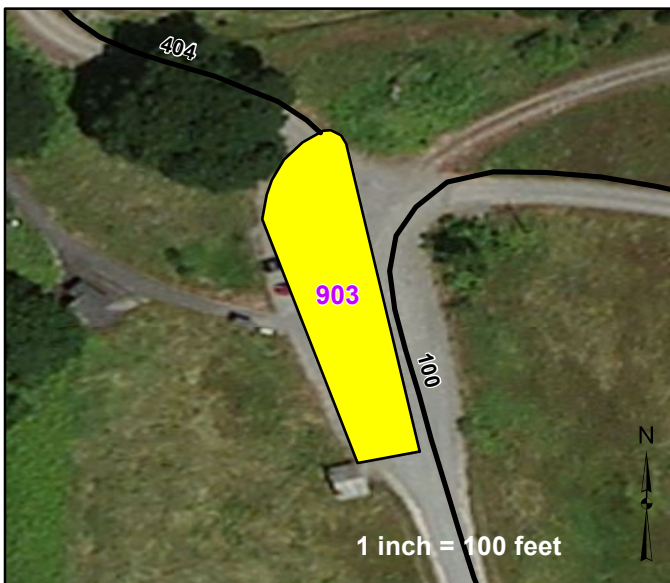
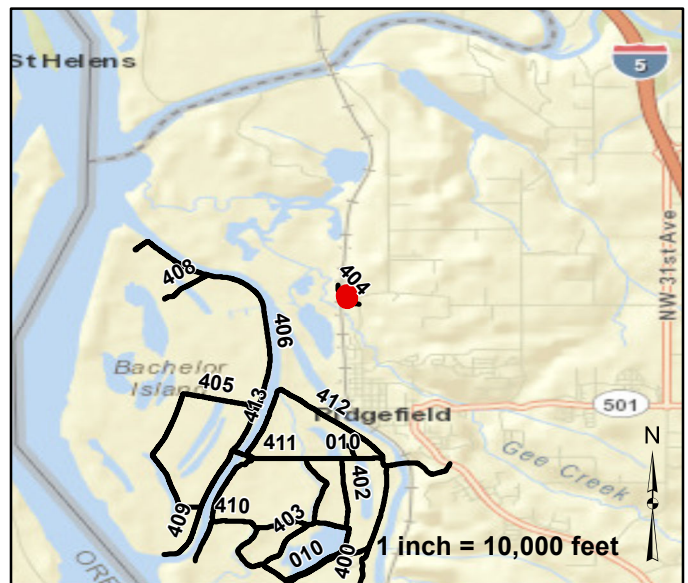
## Route Number: 903

From Carty Unit Access Road (Route 100)

Asset Number	Area (Sq Ft)	Spaces	Condition	Surface Type	Cost to Improve	Inspection Date	Current Replacement Value
-	5006	10	Fair	Gravel	\$1,500	11-29-2012	\$28,600

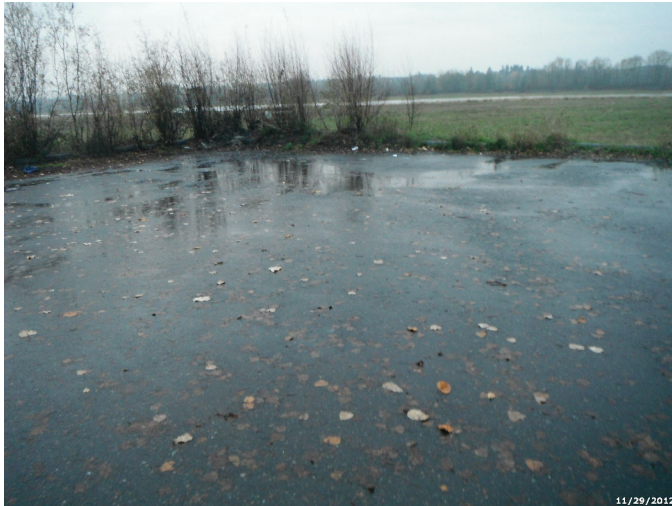
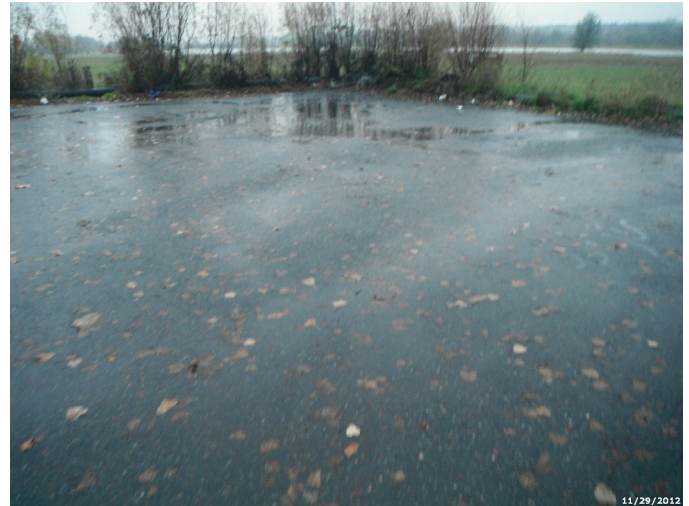
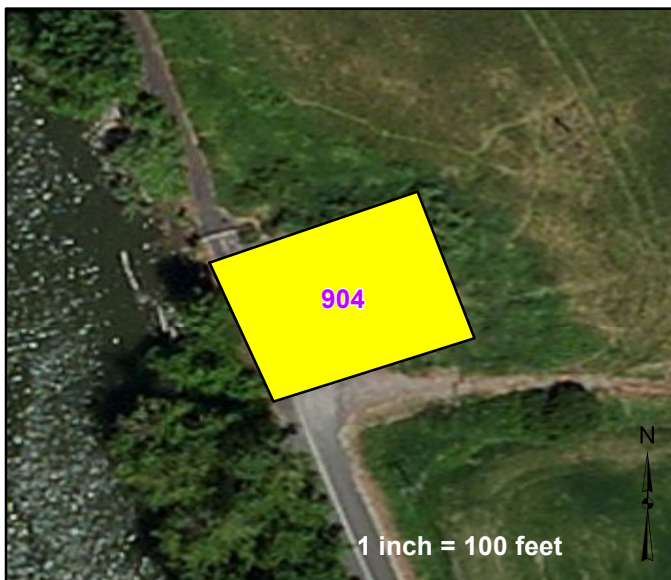
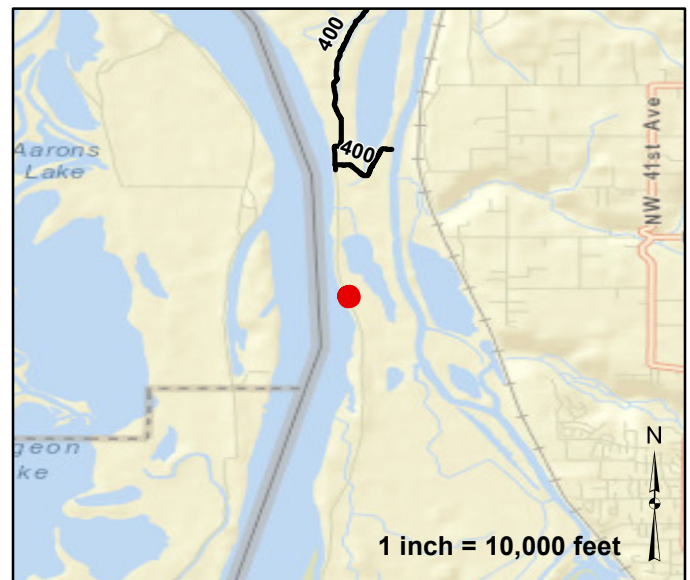
**Route Number: 904**  
**Ridgeport Dairy Unit Parking**  
**From Lower River Road**

Asset Number	Area (Sq Ft)	Spaces	Condition	Surface Type	Cost to Improve	Inspection Date	Current Replacement Value
10003633	6299	10	Fair	Asphalt	\$6,200	11-29-2012	\$66,000

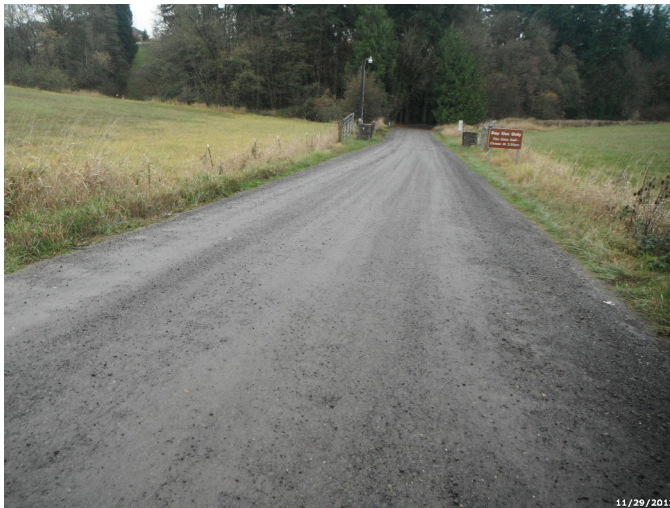
Photo: RIDG\_C4\_4197 Route: 010-001-0.0  
Begin Section

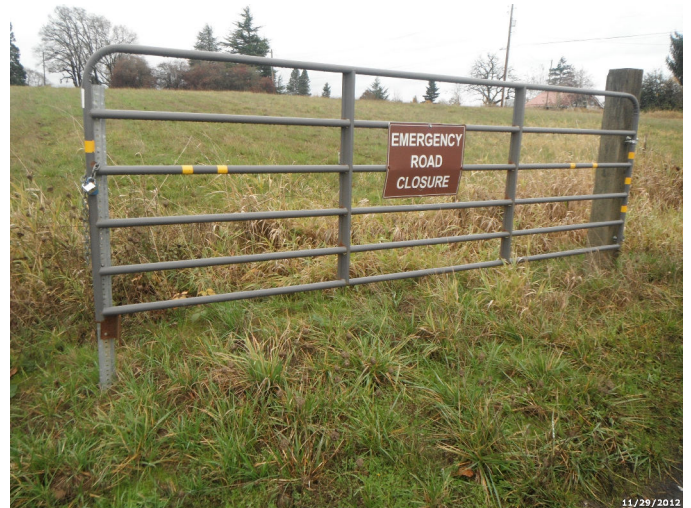
Photo: RIDG\_C4\_4198 Route: 010-001-0.02  
Metal Open Rail Gate

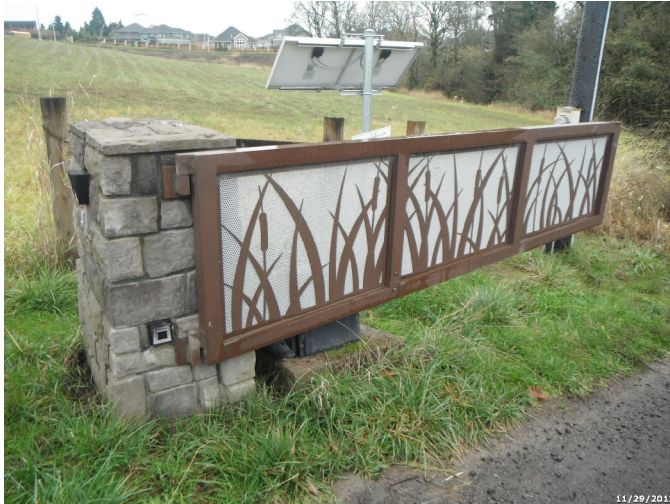
Photo: RIDG\_C4\_4199 Route: 010-001-0.03  
Metal Gate Electric

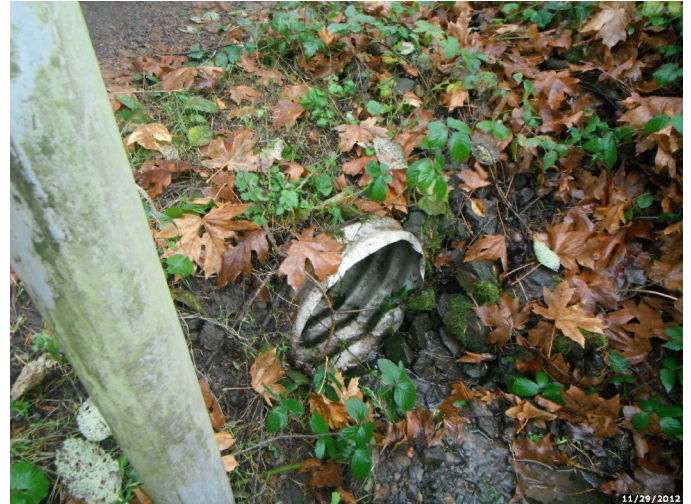
Photo: RIDG\_C4\_4200 Route: 010-001-0.1  
Metal Culvert 35ft long 24in dia. 2ft deep

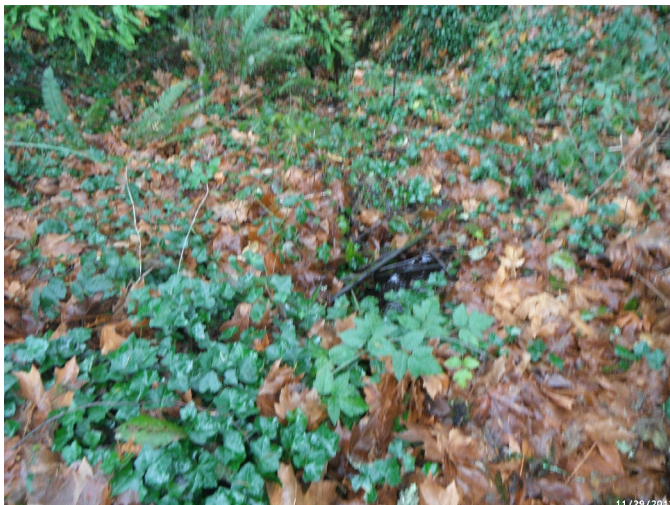
Photo: RIDG\_C4\_4201 Route: 010-001-0.1  
Metal Culvert 35ft long 24in dia. 2ft deep
